## **IMPORTANT SERVICE INFORMATION DUAL MASS FLYWHEEL NOISE WHEN NEW**

**TEC-SX-301-2-2016**

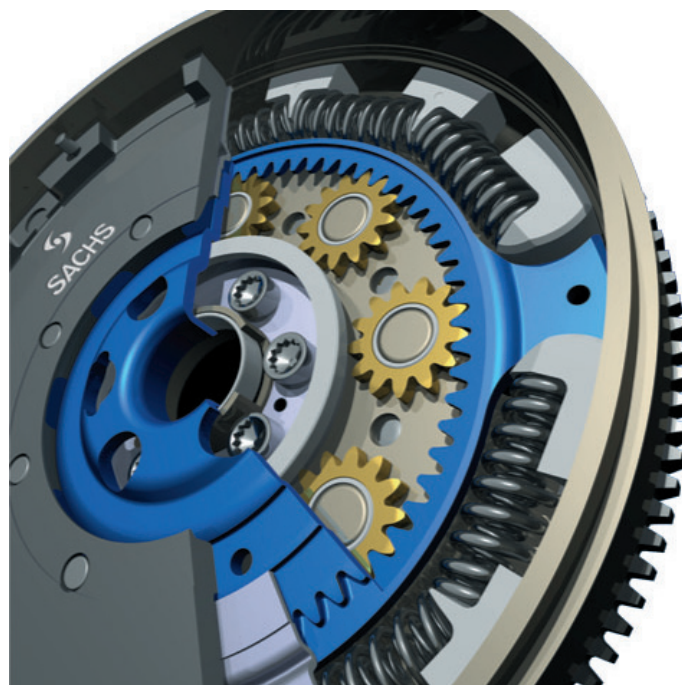
When Checking the Dual Mass Flywheel (DMF) by hand prior to Installation there is a distinct noise as if the internal grease is missing.

This noise is due to a change in the production process; the internal lubricating grease is present but has not fully spread throughout the internal components of the DMF

The DMF is ok to fit, once Installed the engine will need to be warmed up and then accelerated to its maximum RPM briefly. This will allow the centrifugal force to fully spread the internal lubrication throughout the internal components.
