Whatever your thoughts KEEP IT CLEAN

FIRST LINE QUALITY AUTOMOTIVE COMPONENTS

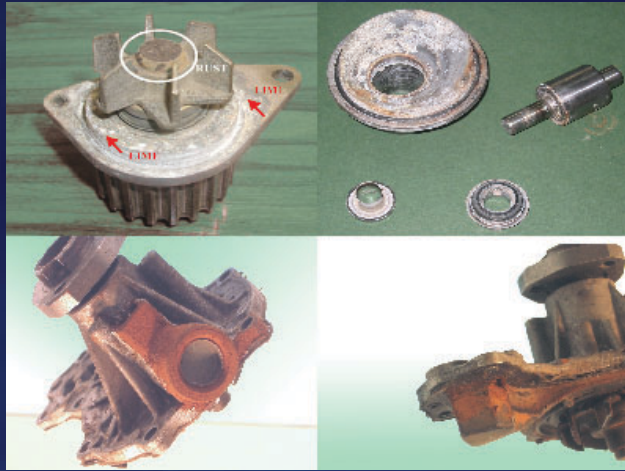
Quality coolant is important!

Before installing any new pump it is necessary to thoroughly flush the cooling system to remove any contaminants, scale and corrosion, some of which may have been dislodged during dismantling of the cooling system. **These contaminants could also be the reason for the failure of the original pump.**

On completion of the repair, the cooling system should be filled with a coolant solution using a quality anti-freeze containing a corrosion inhibitor at the strength determined by the vehicle manufacturer.

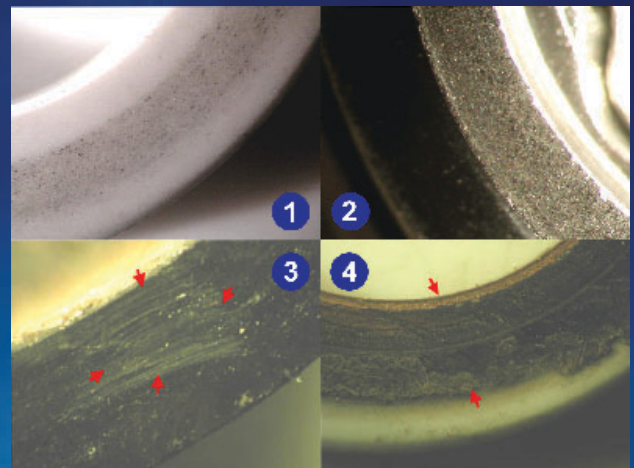
With the aid of an electronic microscope it is possible to analyse the condition of the ceramic and carbon sliding rings of the pump seals. Picture 3 displays the contact area of the carbon ring. The surface is badly worn after working with a coolant solution which contained highly abrasive contaminants. Picture 4 shows the ceramic ring which has evidence of surface deposits. These are the result of working with a dirty coolant solution which contained particles in suspension that have become attached to the seal surface. The use of defective coolant resulted in pump failure and coolant loss in both instances.

Pictures 1 and 2 show new carbon and ceramic seals.
